4.1 DIVERSION DAM

4.1.1 Structure Overview.

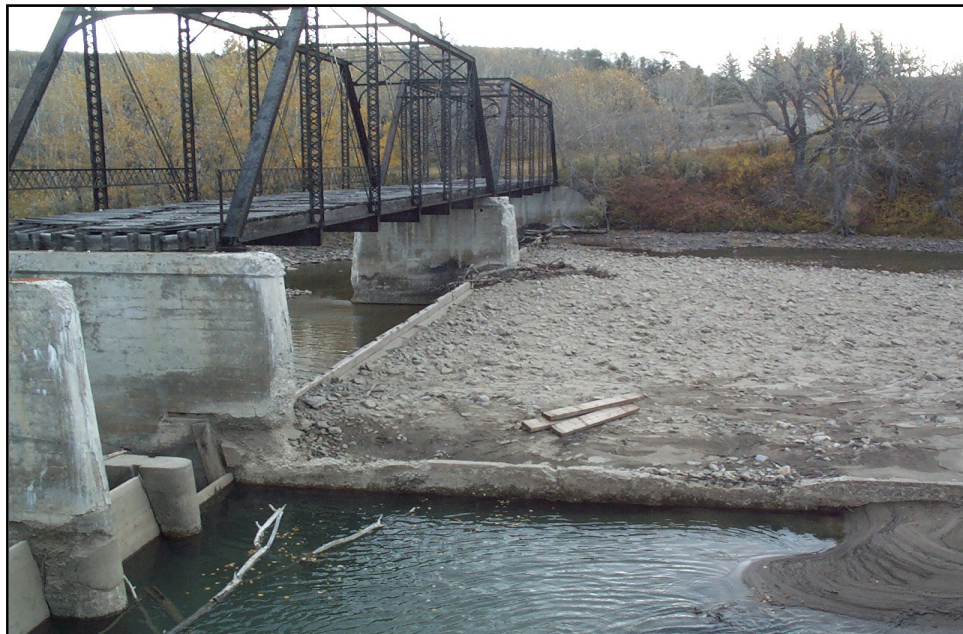
Figure 4.1.1 Looking east across St. Mary River at the two fixed weir segments below the remaining bridge spans. Note condition of concrete, magnitude of sediment deposition upstream of dam and timber plank added to fixed weirs (10/06/04).

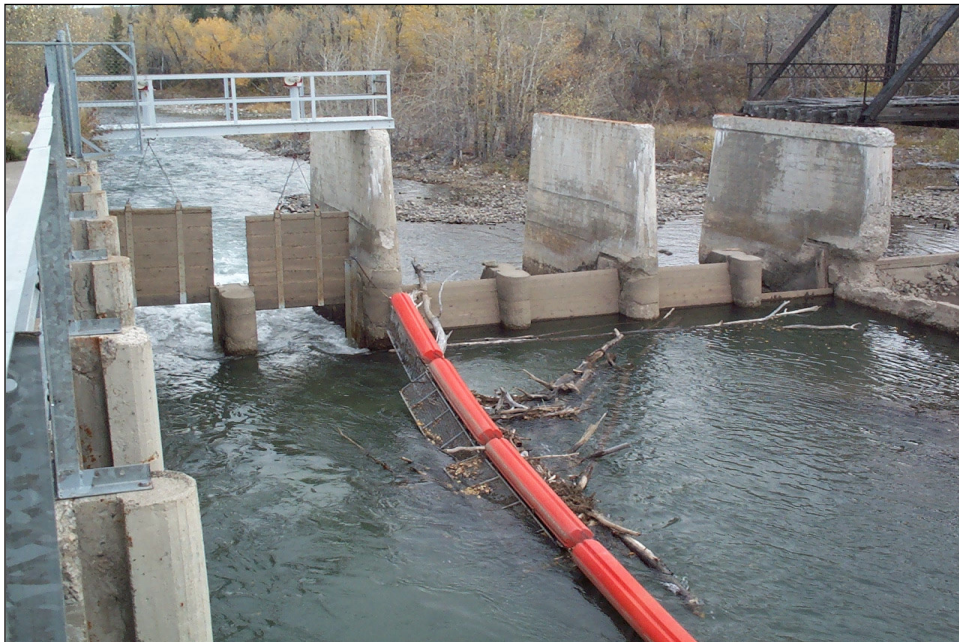
Figure 4.1.2 Looking downstream (north) at three sluiceways on the west side of diversion dam. Canal headgates are left of photo. Note two manually operated lift gates used to regulate flow and permit passage of off-season flow (10/06/04).

A floating trash boom was installed upstream of the dam to divert debris away from an electric fish barrier located on the upstream side of the canal headgates. The effectiveness of this boom is uncertain. Trees generally collect near the end by the dam (Figure 4.1.2).

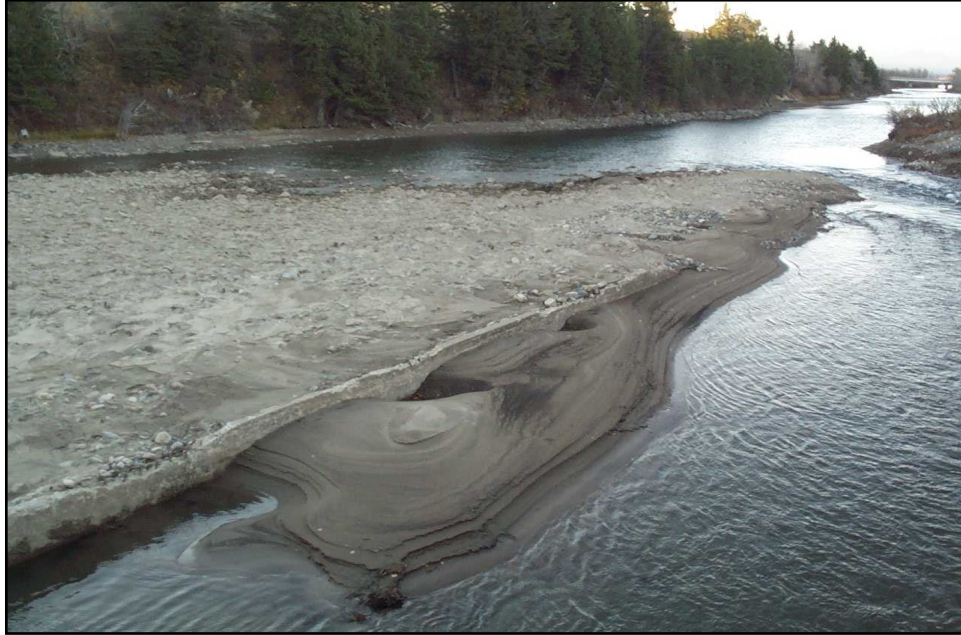
A concrete retaining wall separates the concrete sluiceway channel in front of the canal headgates from the fixed weir portion of the dam. The area behind the retaining wall and upstream of the fixed weir segment of the dam has completely filled with sediment to a point nearly even with the concrete crest of the dam (Figures 4.1.3 and 4.2.6).

Figure 4.1.3 Looking upstream from sluiceway portion of diversion dam. Note condition of sluiceway training wall (10/13/04).

The sediment mound that is building upstream of the dam is having some adverse affects on the river channel. As the mound builds upstream above the dam and headgates, the current is being directed toward the westerly bank where erosion is actively occurring (Figure 4.1.3). This represents a threat to the headgates and upper end of the canal if it isn't controlled or corrected.

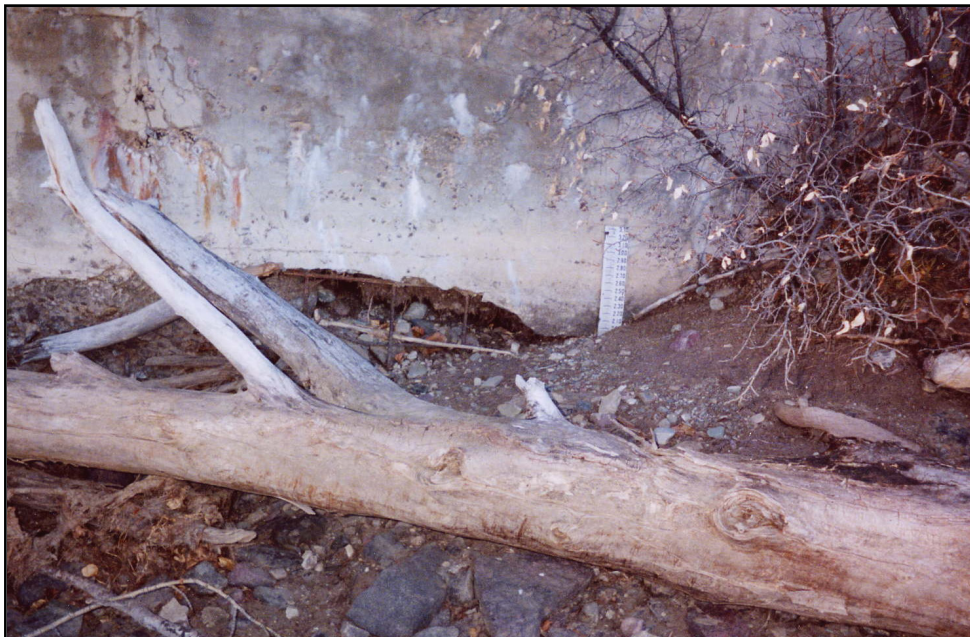
The east abutment of the dam is in very poor condition. Approximately one third of the downstream wingwall concrete is missing and the steel reinforcement (rebar) is exposed. The upstream wingwall also has a large piece of concrete missing with exposed rebar, but the hole was partially filled with sediment and its extent is unknown (Figure 4.1.4). The concrete in the center of the abutment that supports the bridge is in better, but marginal, condition. The wingwalls pose a risk of failure if the channel erodes around the abutment.

Figure 4.1.4 Looking at east abutment. Note condition of concrete and exposed reinforcement (11/11/04).

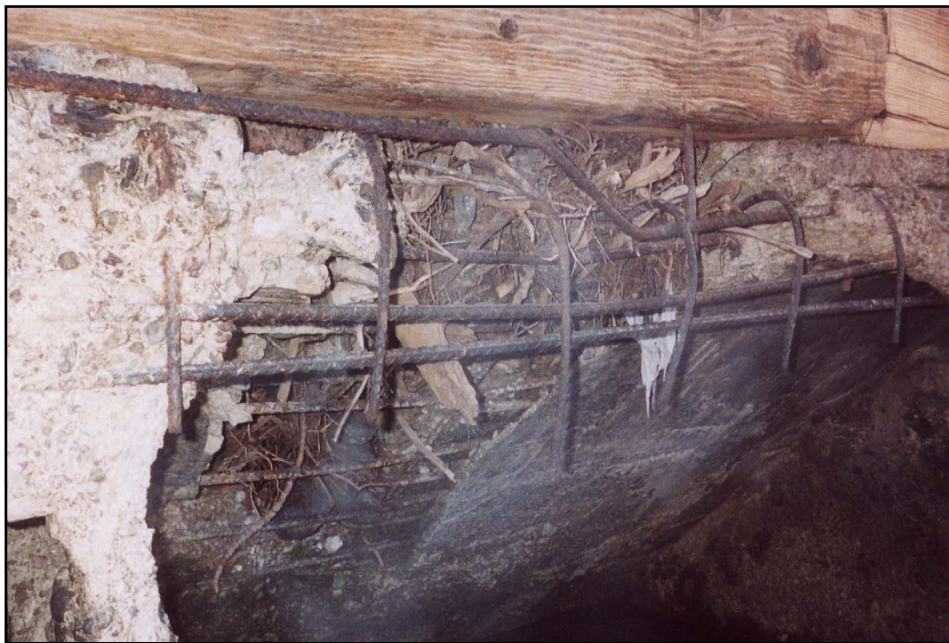
The sloped concrete wall is in very poor condition with large pieces of concrete missing and exposed rebar. In some areas, the rebar forms a net that directly supports cobbles and sediment deposited on the upstream side of the wall (Figure 4.1.5). If the sediment were to be eroded or removed, water would discharge through the holes and the effectiveness of the dam would be compromised.

Figure 4.1.5 View of concrete condition of the underside of fixed weir portion of diversion dam (11/11/04).

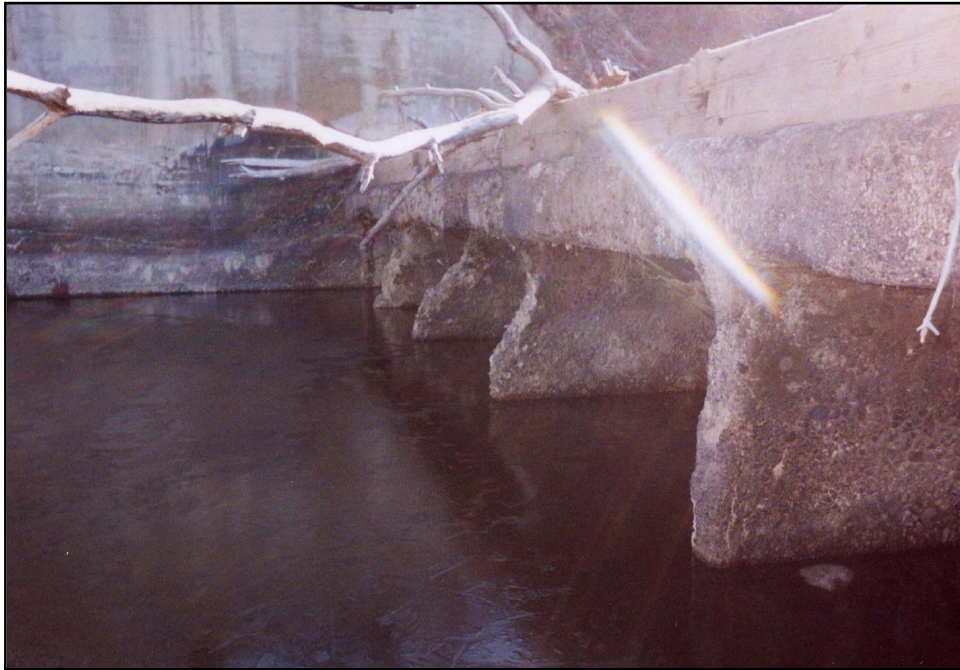
The supporting piers are also in poor condition (Figure 4.1.6). The foundation and apron were under water or ice at the time of our site visit. A thorough inspection was not possible, but the

concrete in general seemed in better condition where it was visible. Previous BOR inspections indicated this concrete is in fairly good condition.

Figure 4.1.6 Looking at downstream side of weir. Typical condition of fixed weir support piers (11/11/04).

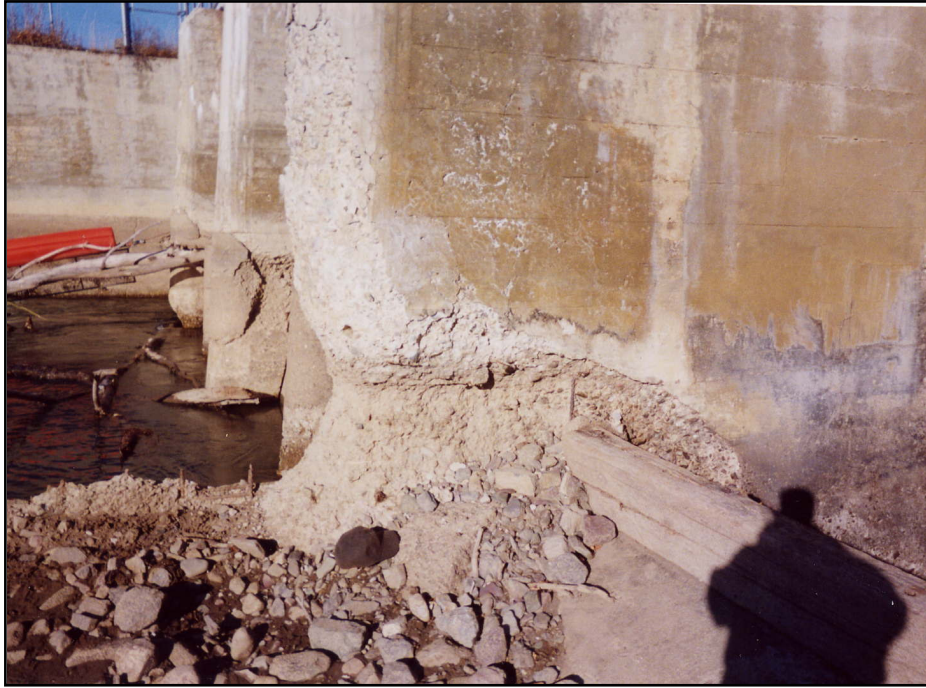
The concrete piers forming the walls of the three sluiceways are badly deteriorated near the waterline. The upstream face of these piers is missing more than a foot of concrete at some locations (Figure 4.1.7). Previous concrete repairs appear to be failing. The downstream portion of some of these piers is also in poor condition (Figure 4.1.8). Large holes extend deeply into or through the piers. The guide slots for the stop logs are deteriorating. Metal guide frames have been installed in the westerly sluiceway for use with the wooden gate panels.

Figure 4.1.7 Looking west at upstream edge of sluiceway piers. Note concrete condition and exposed reinforcement (11/11/04).

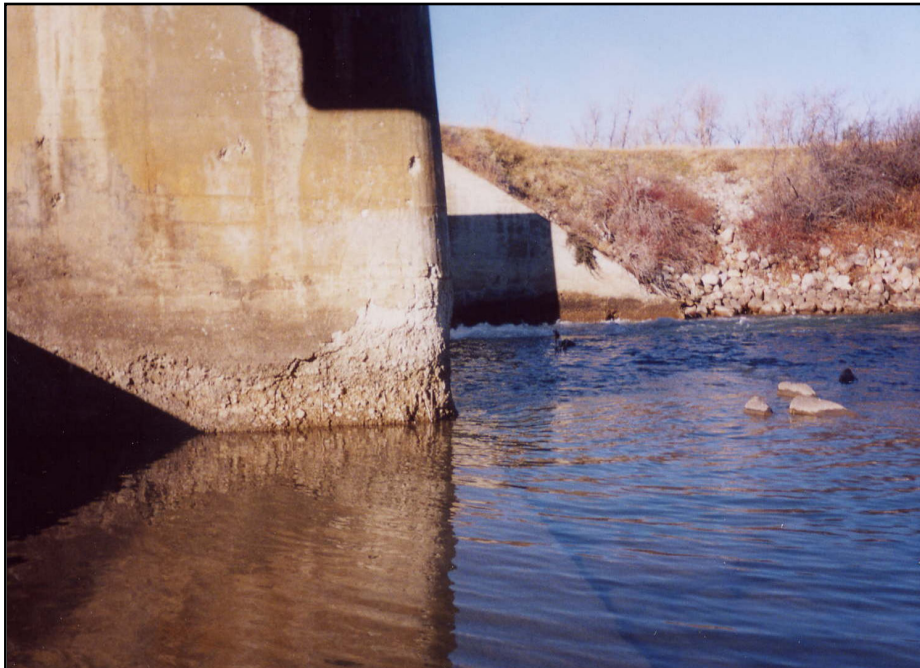
Figure 4.1.8 Downstream edge of sluiceway piers (11/11/04).

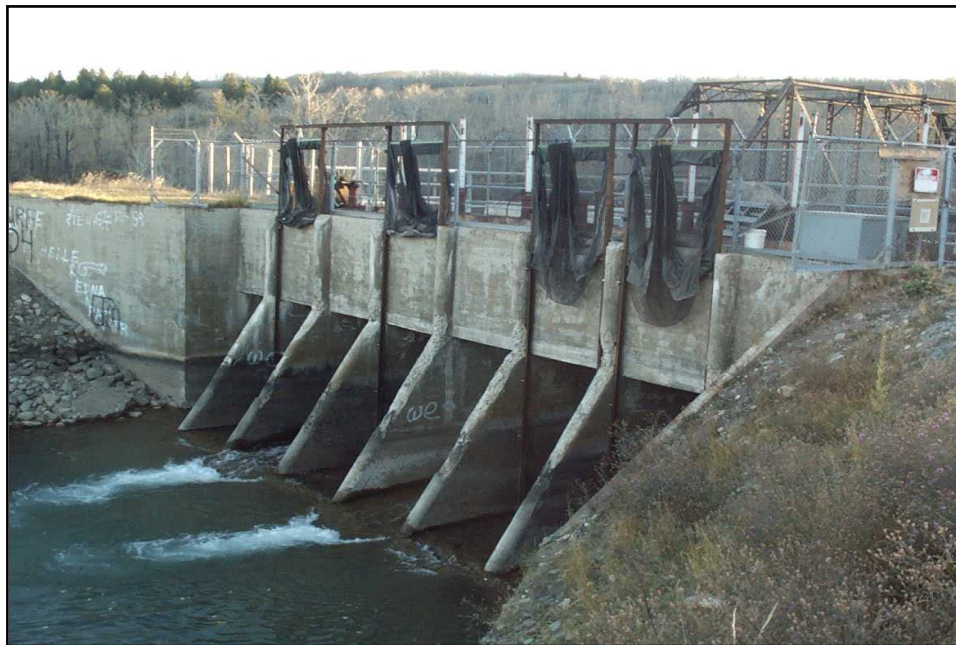
Figure 4.2.1 Looking at downstream end (canal side) of headgate structure. Diversion dam is located behind headgates (10/13/04).
